## REVITALIZING THE ENVIRONS OF HISTORICAL CORE OF THANJAVUR

### ABSTRACT:

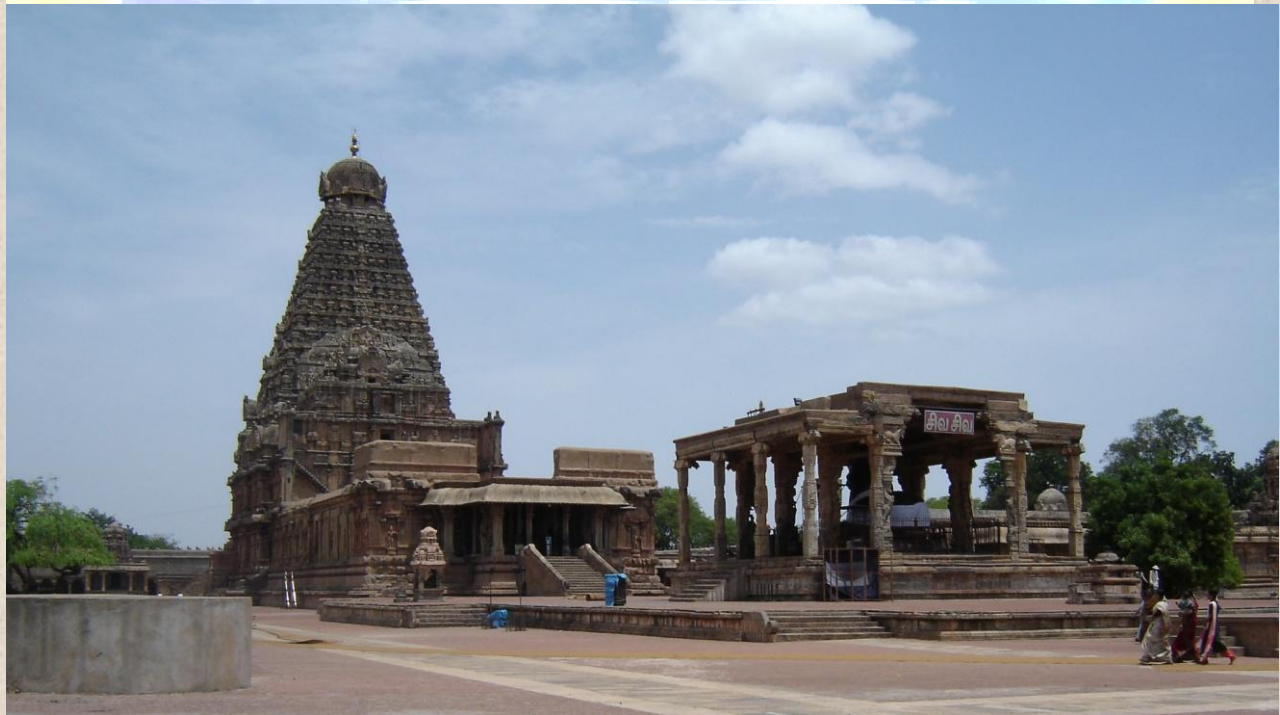
Figure 2: Brahadeeswara Temple, Thanjavur

The great Chola King, Rajarajan (985-1014 A.D.) built Rajareswaram - the Brahadeeswara temple (refer fig.2) at Thanjavur, which according to experts, is a standing classical monument of the Chola style of art and architecture. The temple is constructed of granite, mostly of large blocks, a rock that is not available in the neighbourhood and had therefore to be brought from a distance, that itself a colossal task. The plinth of the Central Shrine is 45.72 sq.m., the shrine proper 30.48 sq.m. and the vimana 60.96 m. high. On the massive plinth, covered throughout with inscriptions, there are niches on three sides in two rows, containing representations of deities such as Siva, Vishnu and Durga. Temple of grand design and majestic proportion, embellished with the works of skilled sculptors, are the visible manifestations of the spirit and culture, priorities and principles, cherished values and beliefs of the people who lived in those days. The vimana of Brahadeswara Temple acts as a visual landmark as well as a city icon. In 1987 UNESCO & Government of India has declared this temple as a World Heritage Monument [Pichard, P. 1995; Gopalakrishnan, P. 2006].

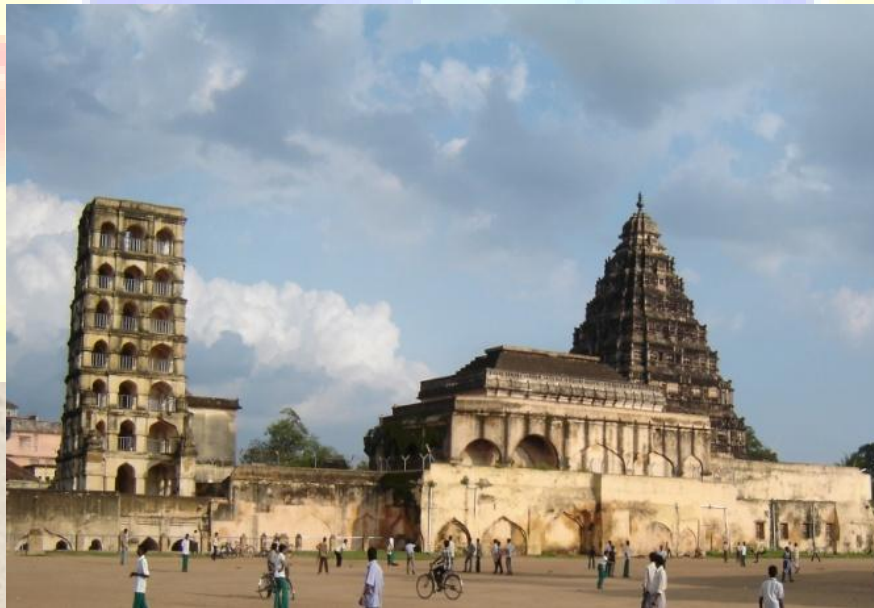
Figure 3: Bell Tower and Arsenal Tower of Palace complex

The palace complex consists of many important buildings of Nayaks and Marattas. Bell tower, Arsenal Tower, Sangeeth Mahal, Darbar Hall and Sarja Madi are the important buildings of the palace complex. Bell Tower is a high rise structure of 32.36 m height, which was used for defence purpose as information transmission tower. Arsenal Tower is the most architecturally rich and attractive building in the entire palace complex. It is of pyramidal shape and has a height of 43.6 m. This tower was built as a pleasure resort for the royal family, by Nayak rulers. Later this building was used for storing ammunitions during war time in British period. Bell tower and Arsenal tower in Palace complex create a varied skyline in the historic core of Thanjavur. (refer fig.3). Sangeeth Mahal is used as an audience hall, where dance and music activities were performed. The royal family used this hall to view the performance and to enjoy the concerts with all comforts in privacy. The Darbar Hall is beautifully decorated with fresco paintings in the walls and ceilings. Darbar hall was used as an official meeting place during the Maratta Period. Sarja Madi is in the eastern part of the palace complex, built in the indo-saracenic style. It is a six storied structure, known for its architecturally rich projecting balconies [Gopalakrishnan and Pushplatha 2007].
