INTANGIBLE BANK EROSION: A THREAT TO THE LIFE OF MATLA-BIDYADHARI INTERFLUVE IN SUNDARBANS

Jayanta Gour*

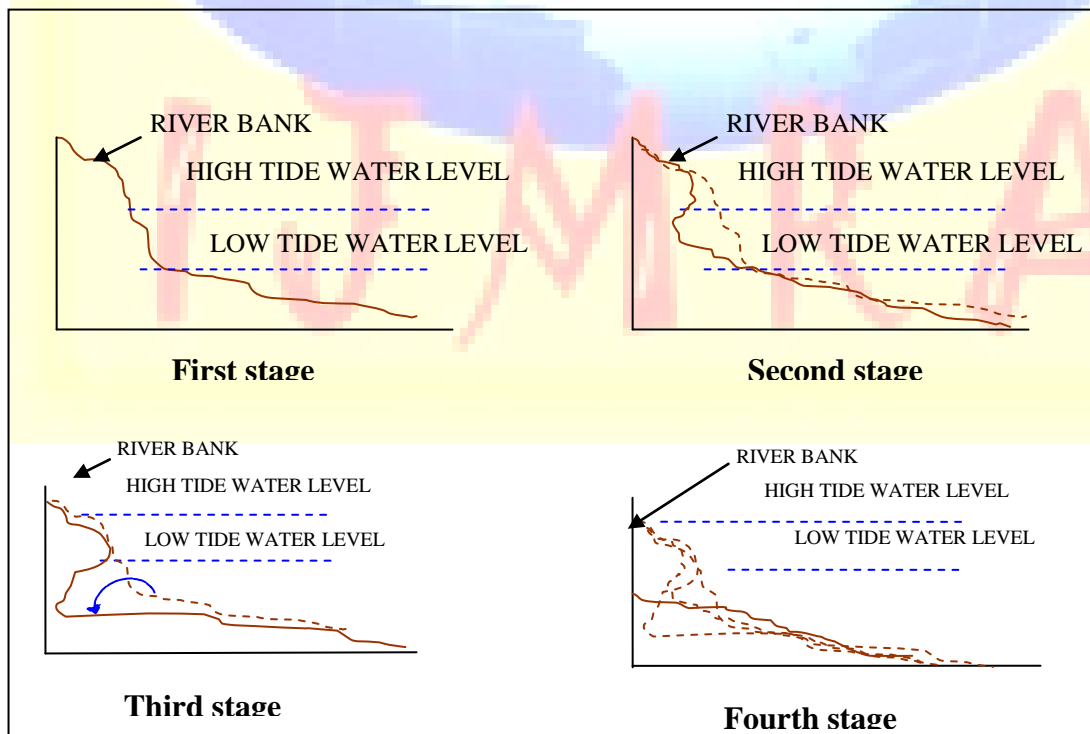
returning outflow of tidal water associated with sweet water of the rivers do not follow the same route. Thus small eddies are originated daily around the areas of the base of the banks wherever they get an ideal place. In the First stage (Fig. 2), we see the banks with the high tide water line hitting the base of the banks. In the Second stage, erosional works of the tides weakens the basement of the banks and continuous wetting and drying twice a day make the banks deficient to bear the hydraulic pressure of the larger waves. The broken brown lines are indicating the previous positions of the banks. In the Third stage, an eddy is originated enlarging the hollows and the air trapped joints or crevices. Thus the hollow slowly enlarges due to the undercurrent at the basement. From the third stage, the erosional processes actually starts by the low tide water level at the basement of the banks and undercutting process continues even after the withdrawal of the tidal water i.e. during the ebb periods. Scouring and enlarging of the hollows at the toe of the banks goes on by the erosional action done by the low tide water at the hollows or bores. Ultimately, in the Fourth stage, the upper portion of the bank collapses on the river and forms semi-point bar at the side of the bank with the deposited material accumulated during the breakage of the banks. It is a continuous and most common process of bank failure in the Sundarbans.

Fig. 2: Diagrammatic representation of the bank erosion by undercurrent in the tidal channels of Sundarbans

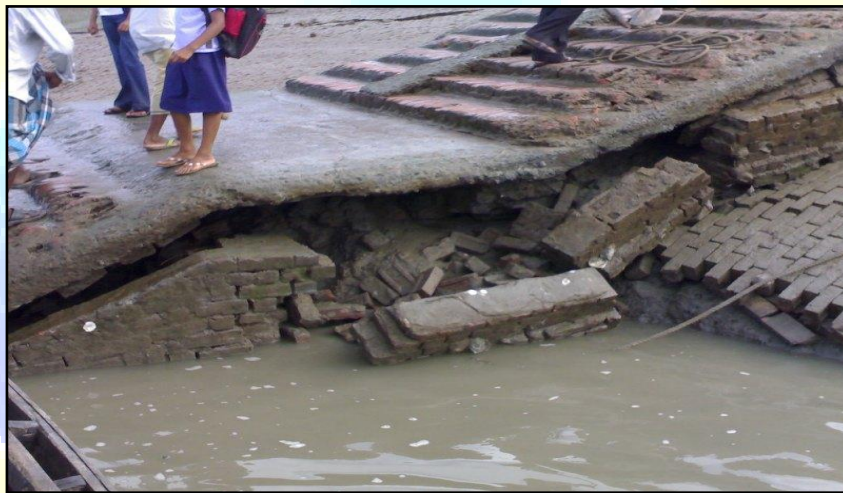
Plate 1: Erosion due to undercurrents at the ferry ghat near Basanti Bazaar, 2008
